## Memo

*Date:* Dec. 20, 2012 (Posted Dec. 22, 2014)

*Subject:* **ATF Shielding Verification via beam Fault Studies Summary**

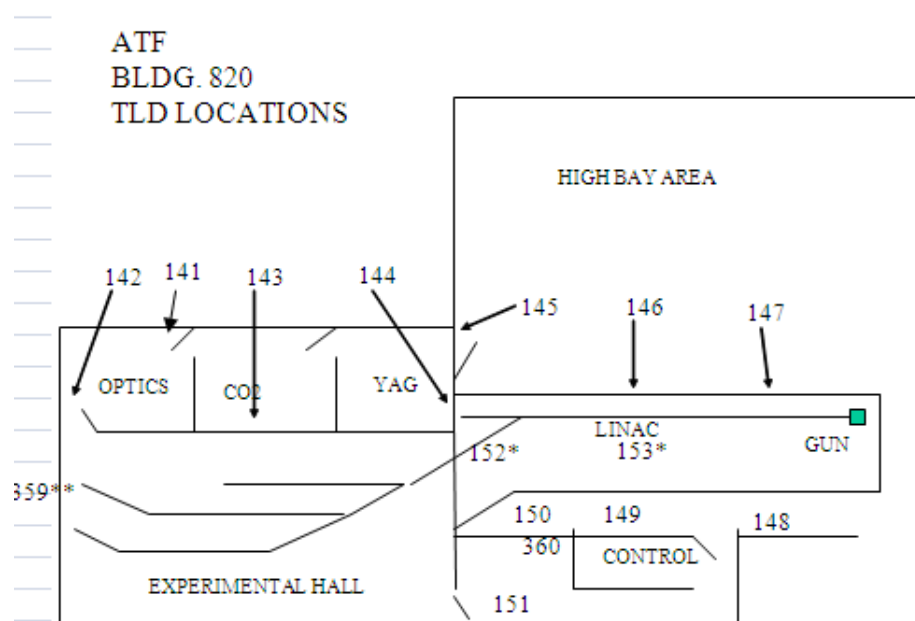
**Figure 1: Monitor TLD locations for 2011.**

There are eleven monitor TLDs that are used to monitor the integrated neutron and gamma radiation on a quarterly basis. The number scheme has recently changed and Figures one and two below show the locations. In recent years the TLDs are consistent with zero elevated gamma radiation except the one near the east gate (about 30 mrad/yr), the CO2 room (about 10 mrad/yr), and the north end of the west hallway (about 10 mrad/yr). Many of the years displayed in Table 2 of the ATF SAD do not have the background subtracted. This mistakenly gives the impressions that the side walls typically have 50-60 mrad/yr of gamma dose. The average yearly background gamma dose for 2005-2010 is 54 mrad.

The neutron doses measured on the monitor TLDs are typically less than 10 mrem/yr. A few exceptions are the TLD at the end of the mezzanine (19mrem/yr), the north end of the hallway (250 mrem/yr last two years) and the TLD near the east gate (24 mrem/yr last year).
